# Navajo Abandoned Uranium Mine

## Site Screen Report

**Mine Name: NA-0750**

**April 2012**

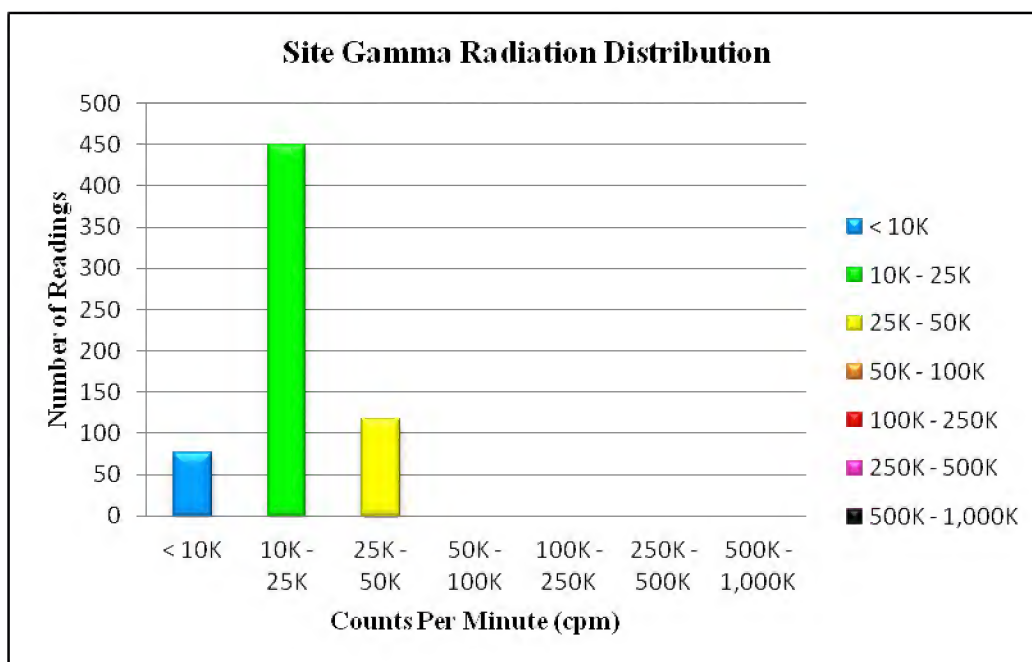
### Distribution Chart and Statistics:

Site Gamma Radiation Statistics	
Number of Readings	642
Minimum (cpm)	7,236
Maximum (cpm)	41,443
Mean (cpm)	17,756
Median (cpm)	16,356
Standard Deviation	6,891

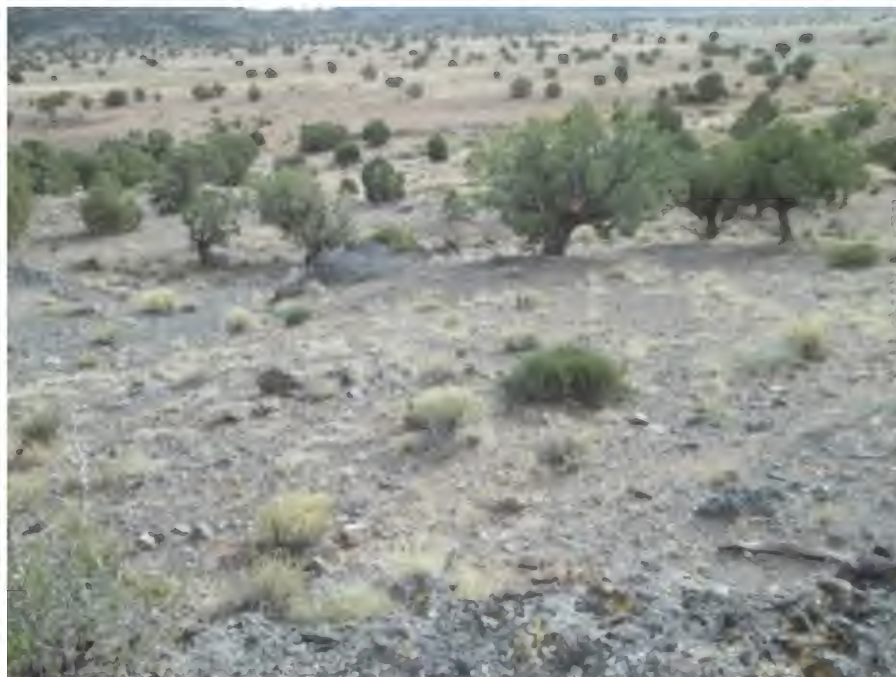
**Photo 1**

Mine Site #89

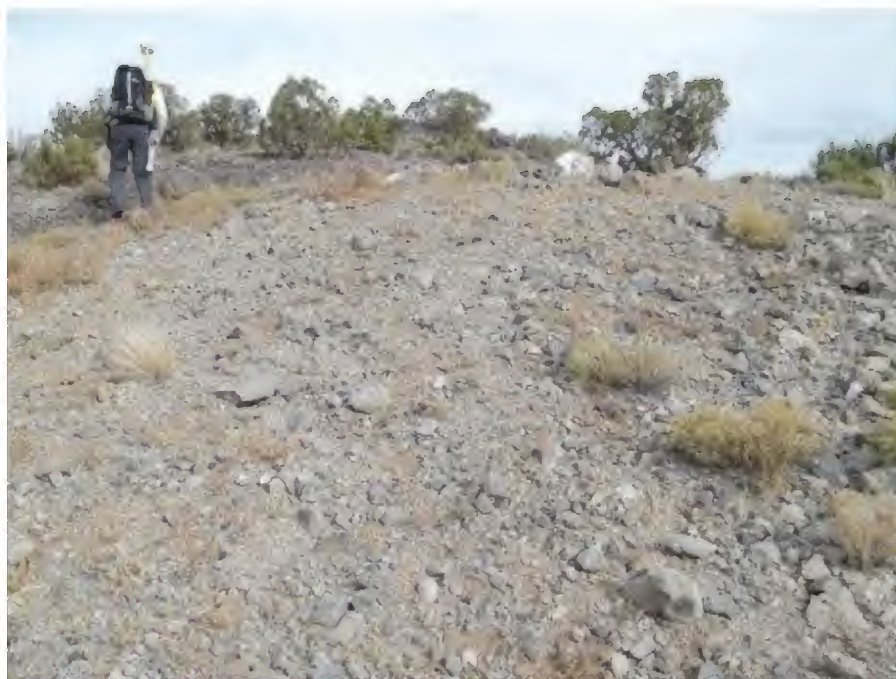
**Photo 2**

Mine Site #89

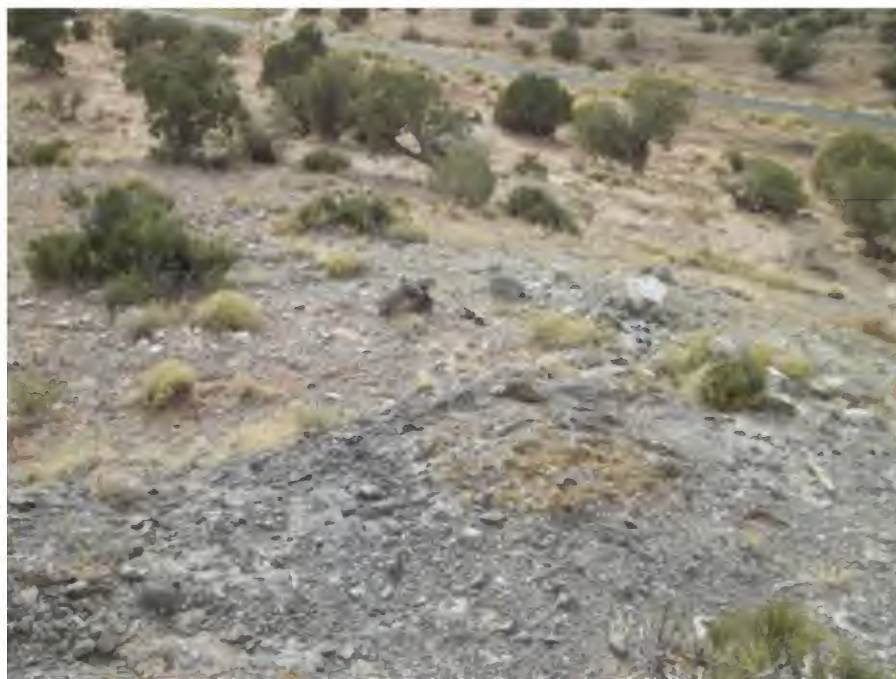
**Photo 3**

**Mine Site #89**

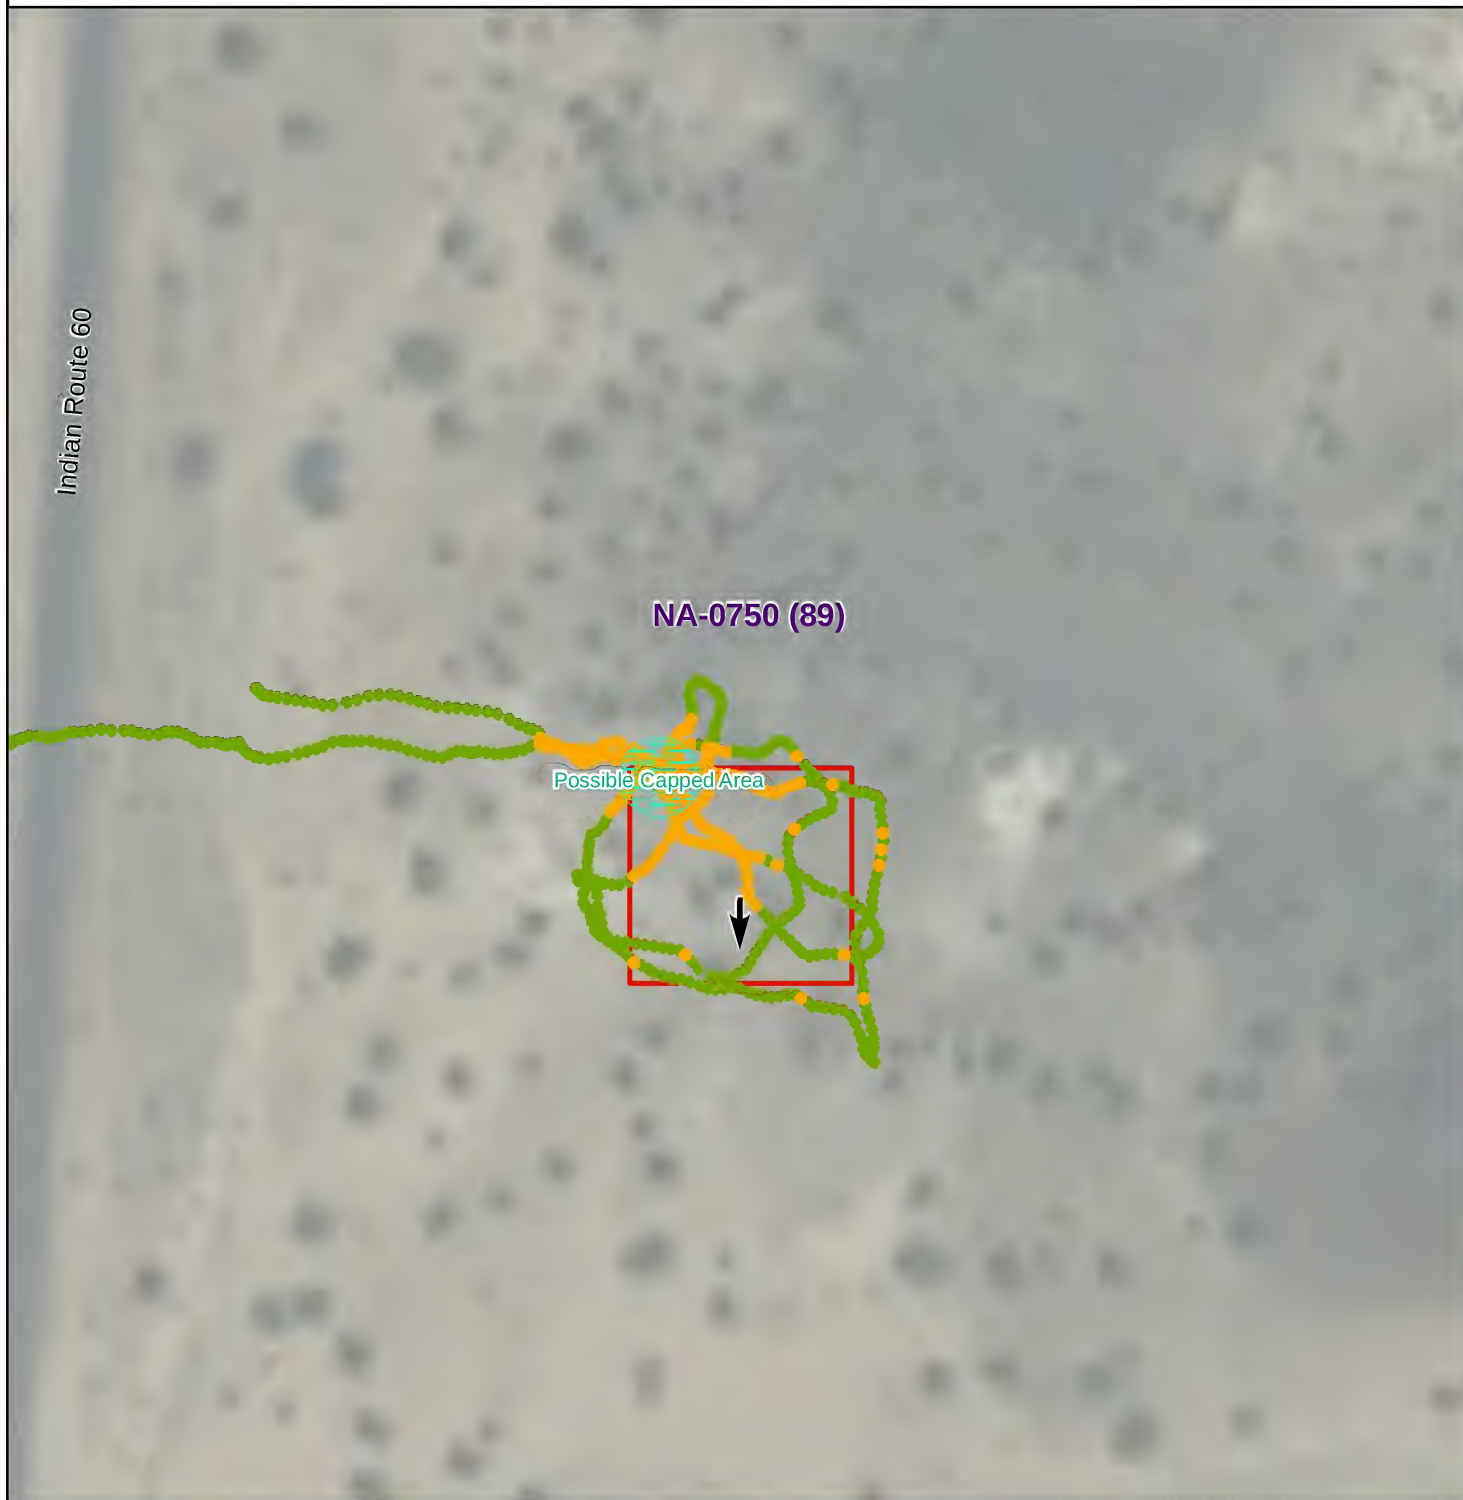
**Figure 1 - Gamma Radiation Measurements, Above Two Times Background  
NA-0750 (89)  
Teesto Chapter, Navajo Nation**

A total of 642 gamma radiation measurements were collected from the mine site, ranging from 7,236 cpm to 41,443 cpm. Maximum levels of approximately 40,000 cpm were found near the reclamation cap. The measurements are represented in Figures 1 and 2.

Average background 9,108 cpm

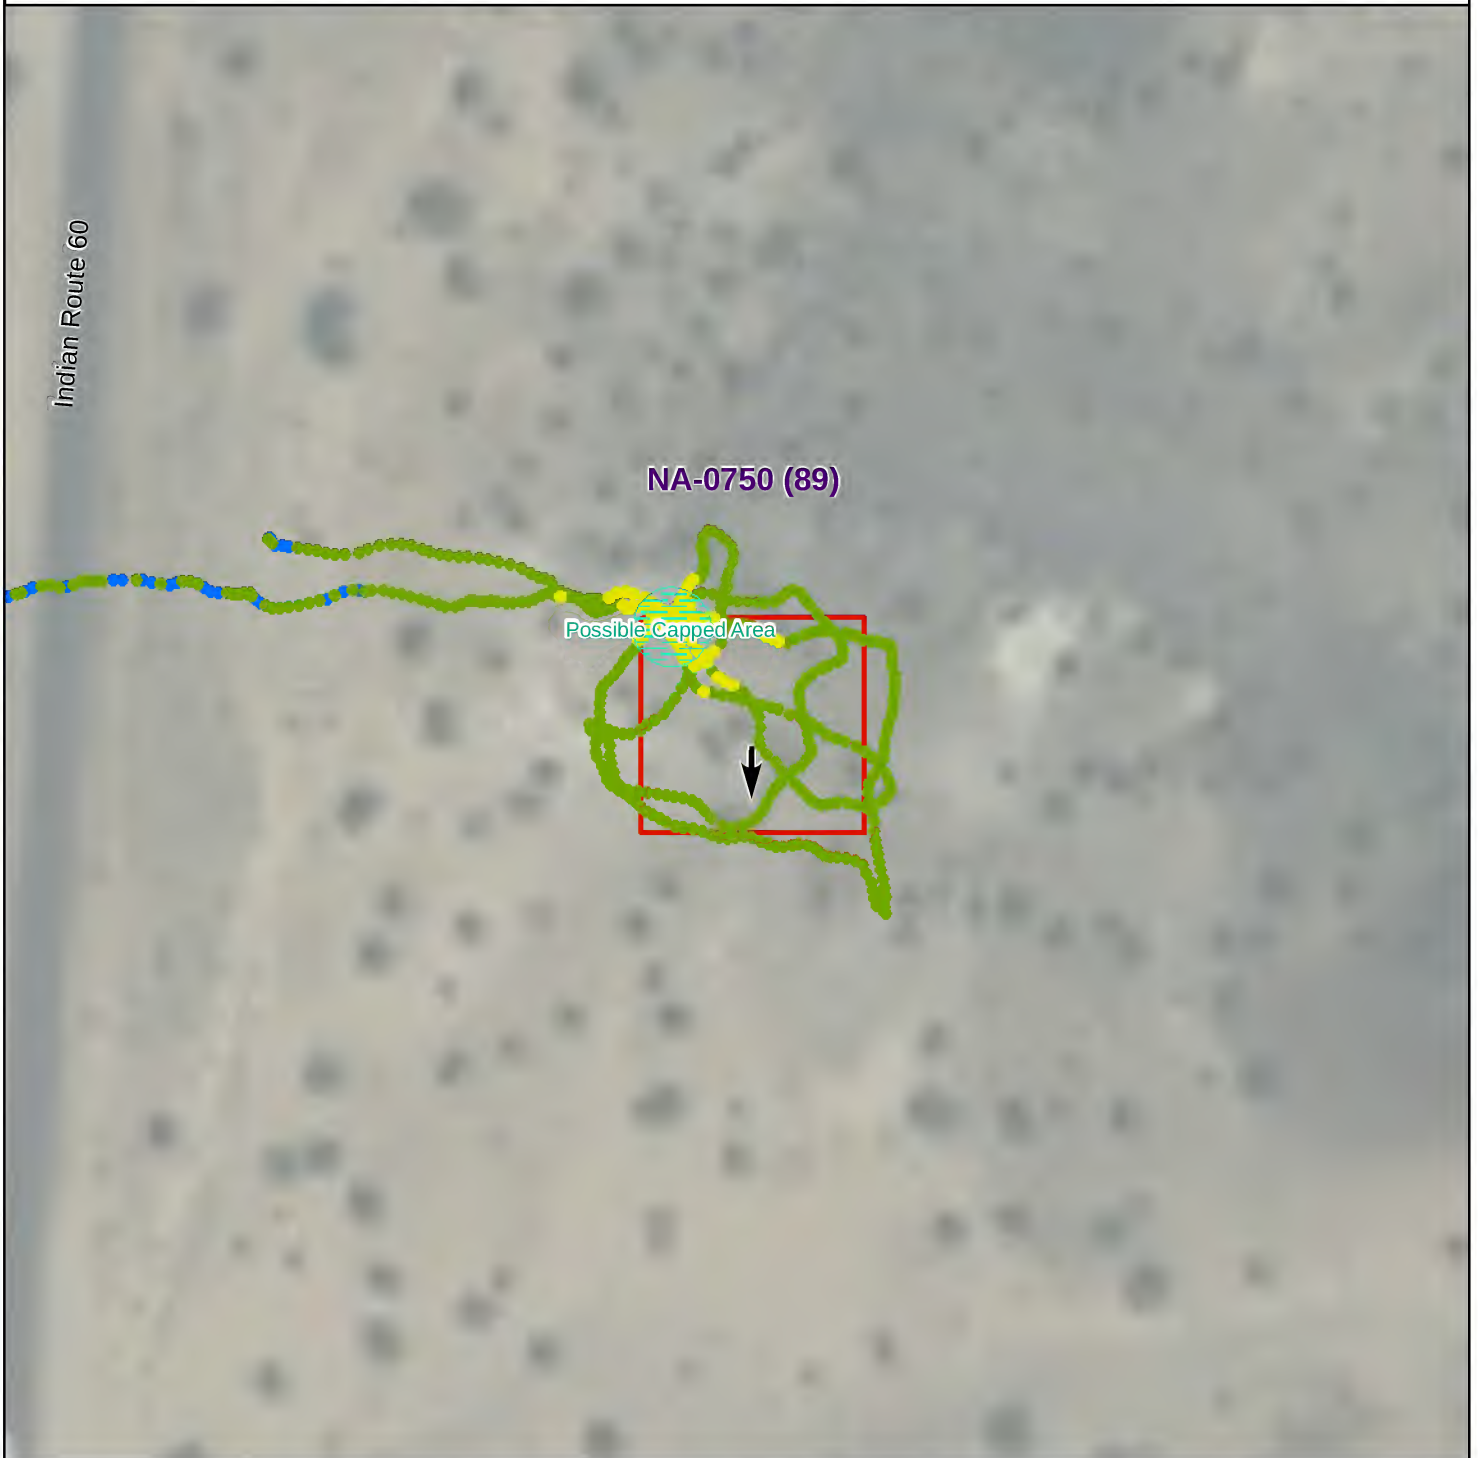
**Figure 2 - Gamma Radiation Measurements**  
**NA-0750 (89)**  
**Teesto Chapter, Navajo Nation**

**Average background 9,108 cpm**
